International Journal of Development Research

CHARACTERIZATION OF NATURAL STONES USED FOR THE CONSTRUCTION OF THE FORT IKOMA HISTORICAL BUILDING IN SERENGETI NATIONAL PARK, TANZANIA

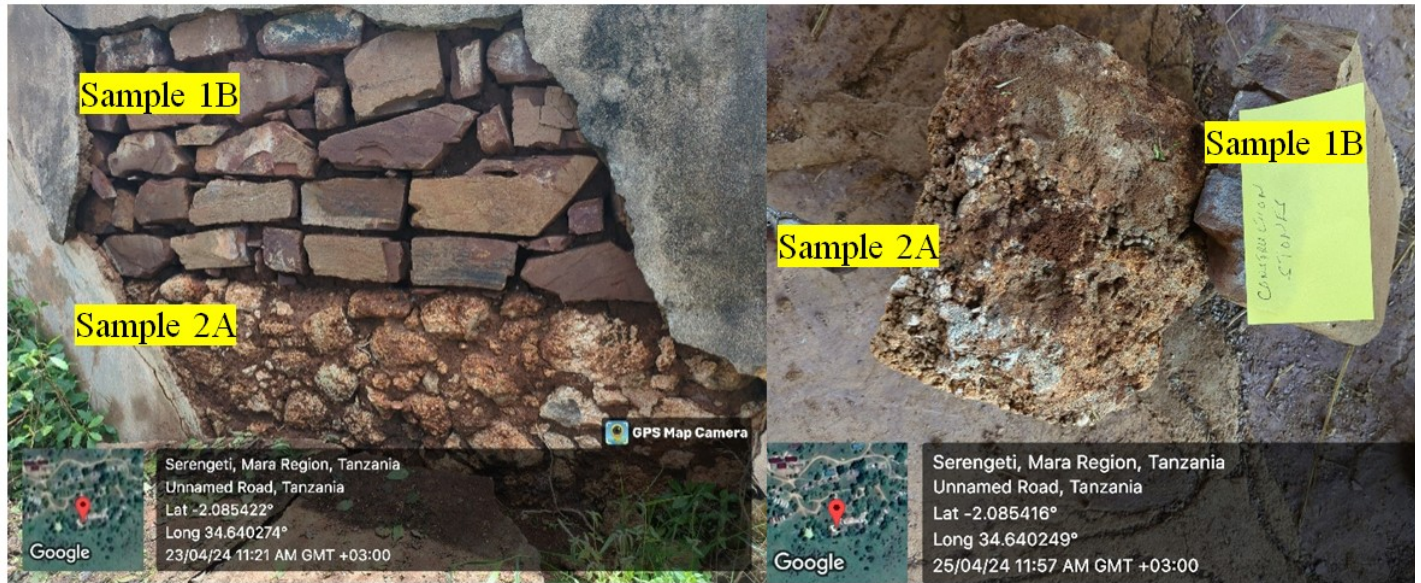
Figure 2. Identified two different natural stone samples used for the construction of the Fort Ikoma historical building in SENAPA, Tanzania

Sample Condition and Nature: The samples are grey to reddish brown (1B) and light grey (2A) colored and composed of clay materials, angular to sub-angular silt to sand-sized grains of quartz and feldspars. The samples have a granular texture, their constituent grains were very fine. These samples were weathered and altered in this case a prolonged weathering and alteration of the silicate-bearing rocks led to the formation of clay-related minerals. The reddish-brown color of the shale sample is due to the presence of iron oxide and hydroxide-related minerals.

Sampling: Through visual investigations, two different types of stone materials were identified (sample 1B and sample 2A) (Figure.2), these samples were collected from areas without aesthetic value or from severely damaged parts. The samples (25numbers) were derived from the outer and inner layers, the ratio between inner and external leaves, the bed and head joints of the outer layer, and the inner core layer (Amer *et al.*, 2021).
