International Journal of Development Research

ASCRIBING THE CAPRICIOUS WEATHER THES IS TO THE UNPRECEDENTED JULY-SEPTEMBER 2022 FLOOD HAZARDS IN THE KUMBA AND MUTENGENE-LIKOMBA AGGLOMERATIONS OF THE SOUTH WEST CAMEROON COASTAL PLAIN OF CAMEROON

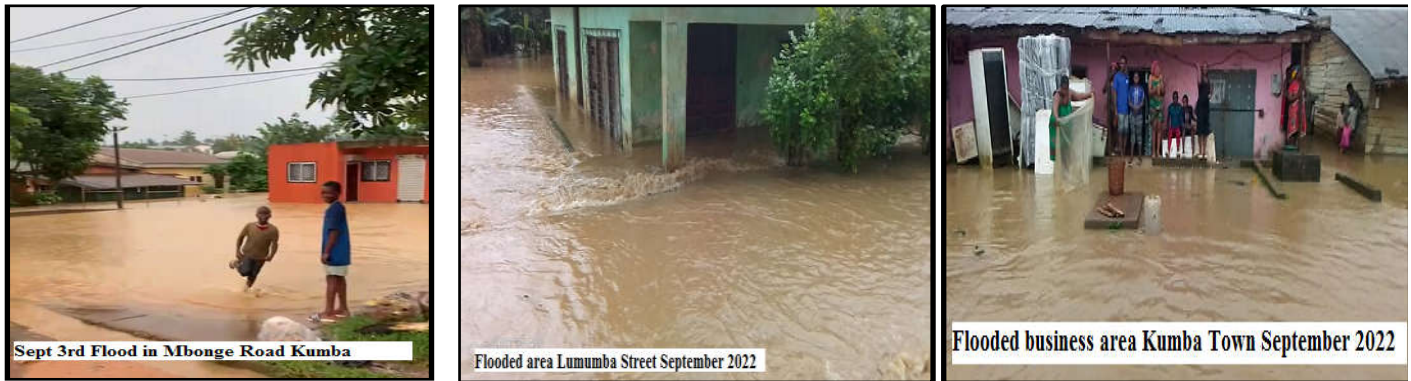
Figure 4. More flooding scenarios in Kumba on 3 September, 2022
Source: Field Work, September 2022

Impacts of the flood Events: The July to September floods provoked intense inundation as usual but with sporadic landslides as the new mark of the floods on the landscape. The consequences recorded are summarised on Figure 3, showing the general and specific spots where casualties were recorded during the flood hazard. More inundation scenarios in Kumba are illustrated by the following pictures.

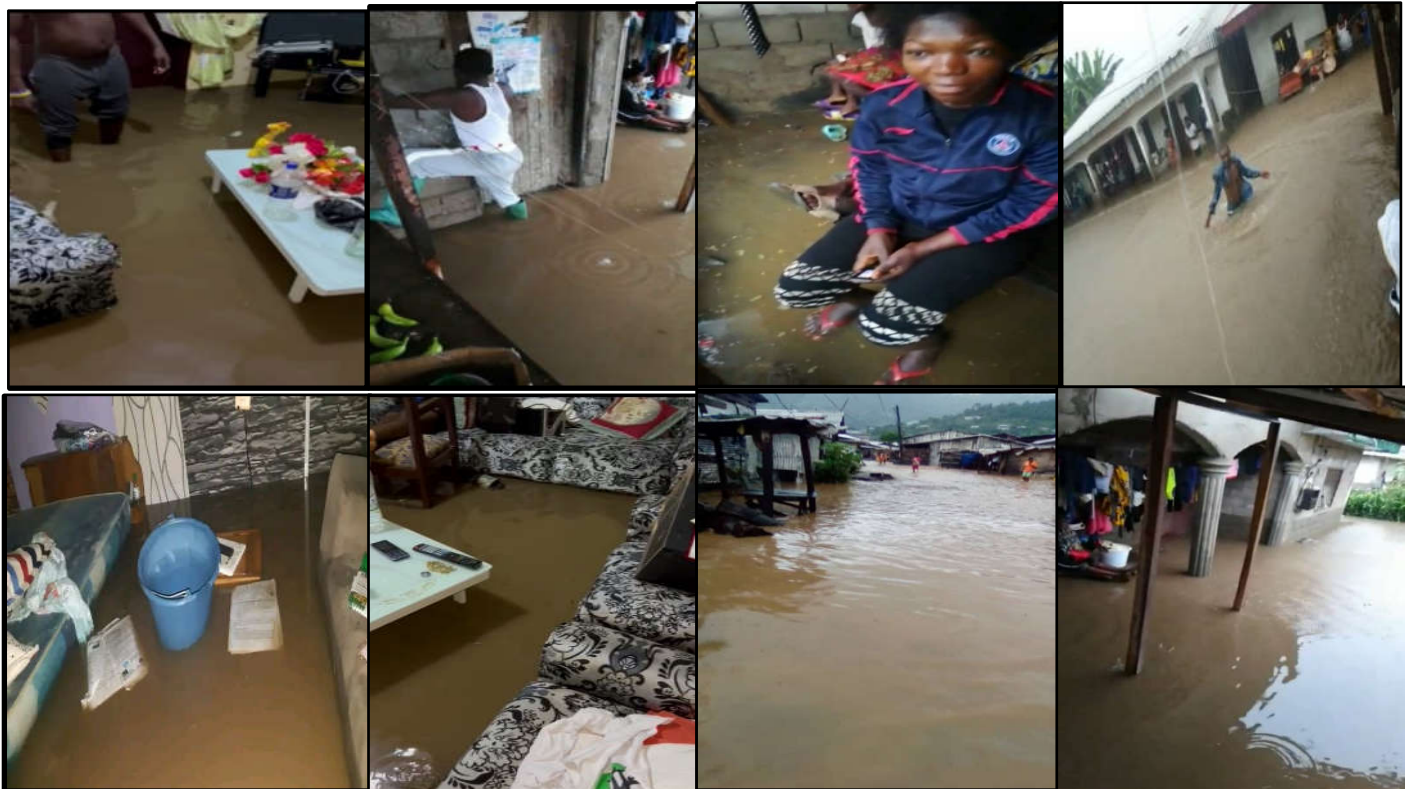
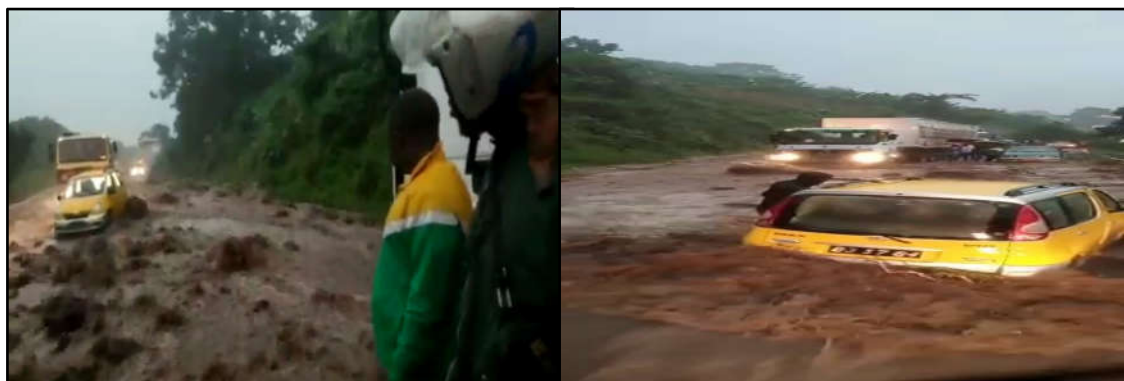
Figure 5: Inundations in the Mutengene- Likomba area on 9 July, 2022
Source: Fieldwork July, 2022

a) Human habitation invaded and drowned by flood waters on 9 July 2022 in Mutengene

b) Unprecedented flood torrents gushing down the Main Road of Likomba Hill on 9 July, 2022

spread and inundate surrounding areas creating ephemeral lakes on the surface. Houses in such locations were drowned by the rising flood waters (Figures 5). This analysis reveals that though the rainfall generated much surface runoff, the terrestrial geography contributed significantly in triggering the floods, landslides and soil slumps of early, July and September, 2022.

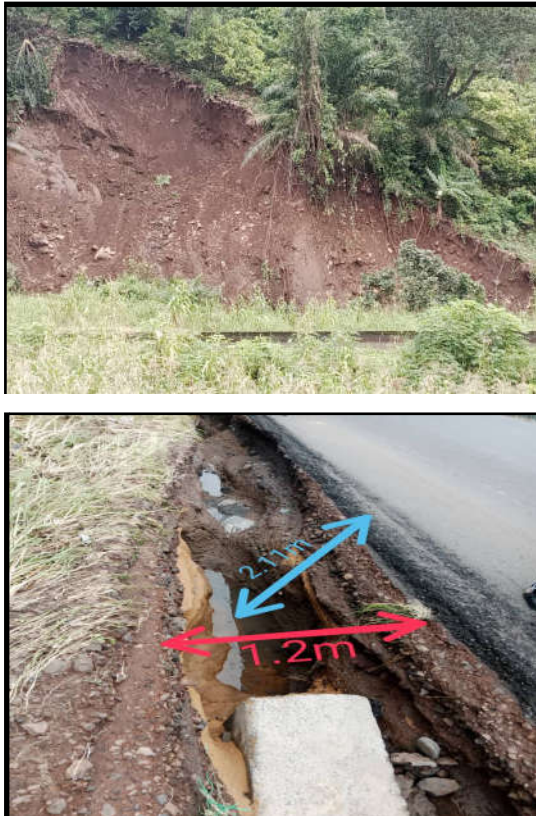
Figure 6: Landslides scenarios after the flood incidences
Source: Fieldwork (2022)

a) Landslides scars and roadside excavations around Police College Mutengene on 9 July, 2022

A new important dimension of the impacts of the flood story was the massive landscape excavation and scarification that emerged. Some pronounced cases are illustrated on Figure 6. Despite the fact that just 2/5 of the landscape in Kumba is characterised by steep slopes, the landslide event has equally put the city on the media headlines recently. Spatial location of landslides remained unaltered as areas along the slopes of central hills (the Hill Top, Baptist Hill and the

Kumba II Council Hill zone) that occupy the north central part of the city, remained the endemic points of landslides in Kumba. Therefore, inhabiting hill slopes in Kumba has become tradition as such areas for long have not posed any real danger to occupying facilities. However, recent events that have associated floods and landslides have put such areas into perspective. The growing intensity, frequency and severity has caught attention and was the conspicuous dimension of these flood episodes. Although the Mutengene to Likomba zone is on a mountain slope, landslides are not frequent. The landslips and scouring of gullies on the sidewalks of the main road by the Police College and the Golf Course areas were new landscape mutations issuing from the 9 July 2022 flooding scenarios. In addition to these symbols of landscape degradation and spoliation, incalculable number of human properties were destroyed in the drowned homes and many livelihood bases and infrastructure bastarded by the flood waters. Within the Mutengene locality at the Lamba Quarter, a poultry was inundated and eight hundred (800) of the fowls drowned. This is shown on Figure 7.

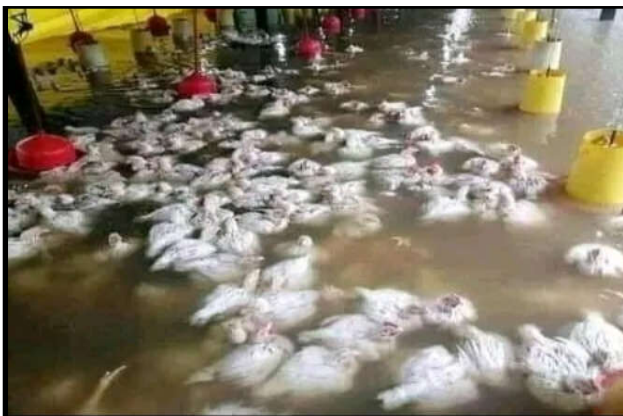
Figure 7. Fowls killed by inundation of a poultry house in Mutengene
Source: Fieldwork (2022)

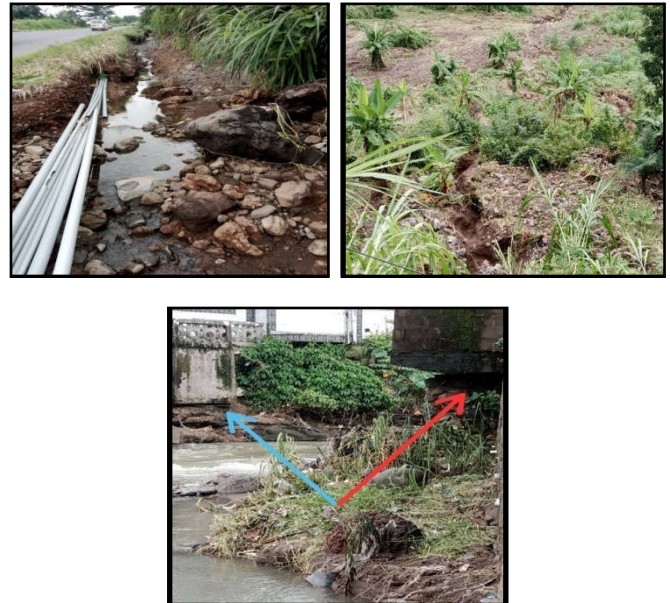
Figure 8. Artificial channels on main road and banana plantations, and eroded reclaimed land at Likomba Area
Source: Fieldwork (2022)

Also, many bags of animal feed bought and stockpiled were sucked beyond usage. Furthermore, the landslides and the flooding that covered the main road at hilltop area in Kumba and the Likomba Hill interrupted circulation for hours. Some vehicles notably taxis that forced their way through the flash floods suffered irreparable damages at their base with about 10 taxis having their engines knocked. Additionally, the 9 July and 4 September floods had another destructive dimension in common. Telecommunication lines of CAMTEL were unearthed and some severed as surface runoff dissected the landscape, engraving artificial channels. These are shown on Figure 8.

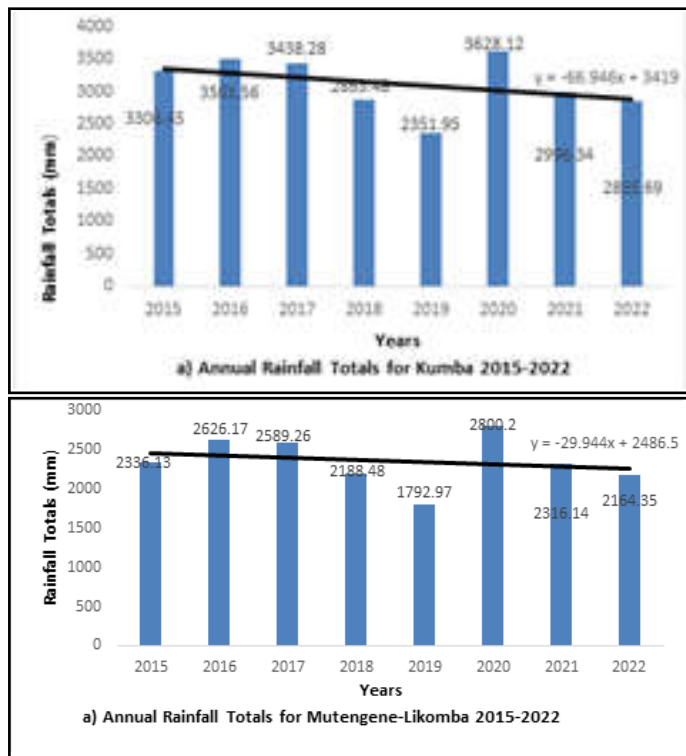
Secular rainfall variability: The Kumba and Mutengene-Likomba areas are located in the equatorial natural region. This places them within the Af tropical climate domain, according to the Koppen-Geiger classification characterised by high rainfall with a general mean rainfall of 2,000 mm. The mean annual rainfall (2015 to 2022) for Kumba (3,117.7 mm) and Mutengene-Likomba (2,351.7 mm) reveals that study areas are high moisture budget flux zones above their regional mean (2,000 mm). Annual trends of rainfall totals shown in Figure 9, reveal overall decline over time.

Figure 9. Secular rainfall variability
Source: Drawn on the basis NASA Climatic Data

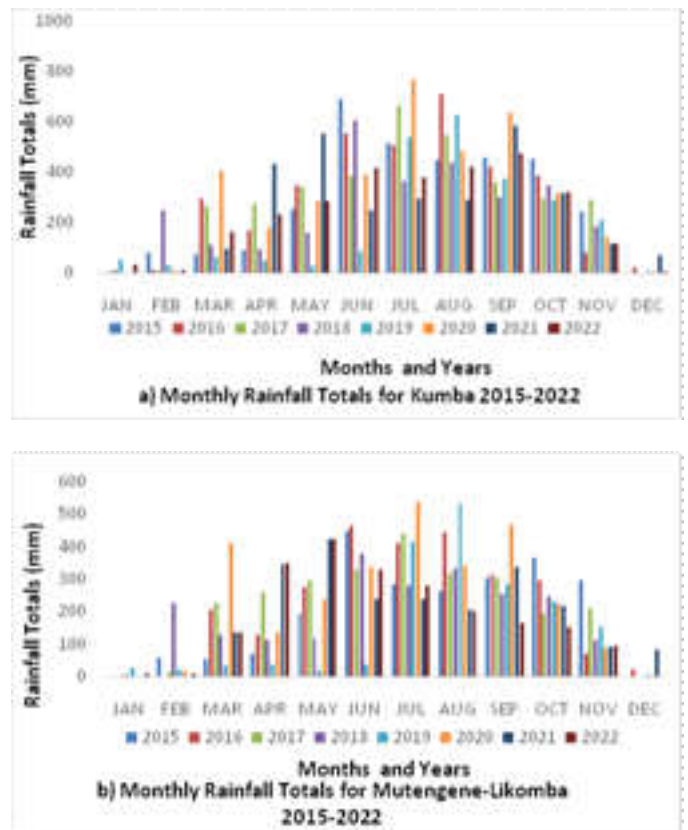
Seasonal Variability: The intra-annual analysis of mean rainfall totals from 2015 to 2022 reveals marked monthly differential in rainfall amounts as shown on Figures 10.

Figure 10. Monthly rainfall totals
Source: Drawn on the basis NASA Climatic Data

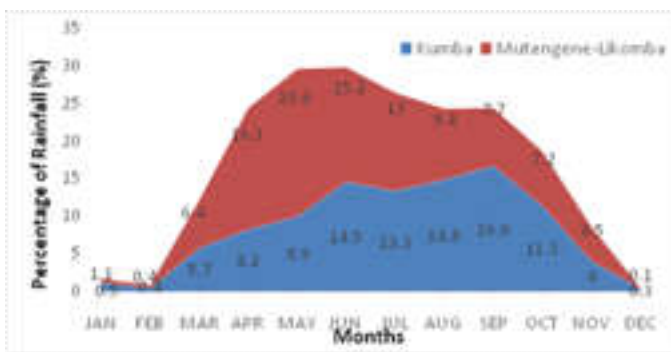
Analysis of the seasonal distribution rainfall in the flood year (2022) exposes critical rainfall-flood linkage facts. The rainy season months in the Kumba area received 2,805.27 mm (98.23%) of the annual rainfall and the Mutengene-Likomba Zone, 2,044.15 mm (94.45%). These proportions were higher than the mean inter-annual rainy season rainfall proportions of 97.35% and 91.1% respectively. The monthly rainfall frequency (Figure 12) corroborates further this inter-monthly variation in rainfall.

Figure 12. Monthly Rainfall Frequency
Source: Drawn on the basis NASA Climatic Data

An even distribution of rainfall across the year would have given a rainfall frequency or concentration ratio 8.3% a month, but unevenness was the occurrence. High rainfall concentration ratios (above 10%) occur in the months of April, May, June and July (63.9% in just four months) in the Mutengene-Likomba zone and June, July, August, September and October (70.5% in five months). It is deciphered from this that the flood months (July in Mutengene-Likomba and September for Kumba) are high rainfall concentration months, with that of Kumba being the month with the highest rainfall concentration. This correlation between rainfall frequency and flood occurrence within these two areas therefore becomes clearer than merely looking at general seasonal distribution. Another dimension of analysis is examining the pattern of rainfall of the two months preceding the flood month and the flood month. This is important because rainy months preceding flood months contribute significantly to surface and subsurface moisture budgets which induce the overland flow that generates flood waters. In the Kumba area these months were July, August and September and in the Mutengene-Likomba zone, May, June and July. The interannual variation of this index shown on Figure 13, reveals that but for the flood month of September in Kumba and May in the Mutengene-Likomba zone where there is an increasing trend, the other months show declining trends.

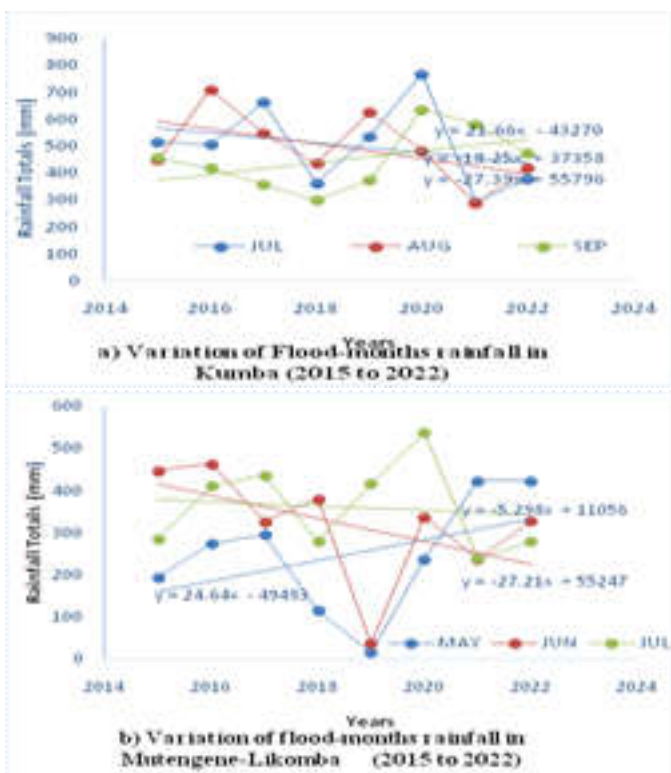
Figure 13. Inter-annual Variation of Rainfall for pre-flood months
Source: Drawn on the basis NASA Climatic Data

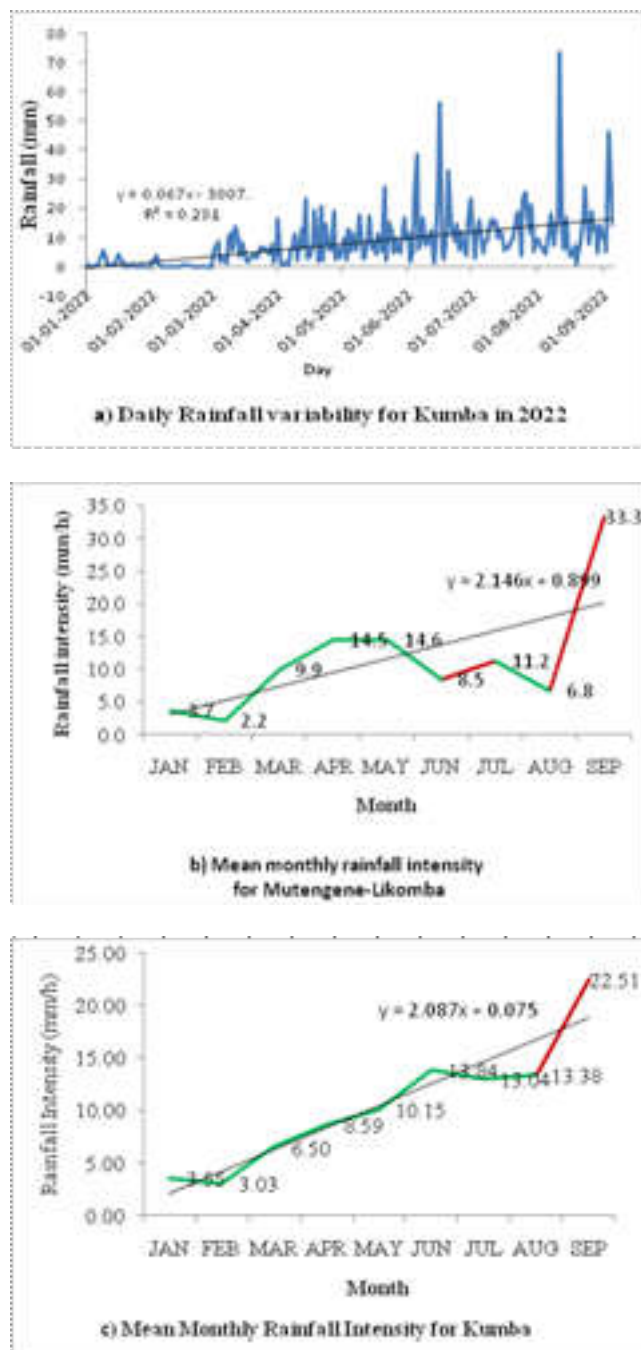
Figures 15 a and b reveal that daily rainfall totals and rainfall intensity increased towards the flood occurrence months. September in both areas. The sudden rise in the flood months was the immediate trigger of the July-September floods. The July 9th 2022 flood hazard in the Mutengene-Likomba zone was the result of two days continuous intense rainfall, and the 4 September floods connected to more than four days of similar rainfall characteristics. These rainfall characteristics brought in abundant input of water to surface, that reduced the infiltration rate consequently generating the great volumes of high velocity overland flow which provoked and sustained the floods that overwhelmed the surface drainage capacity. Furthermore, the torrents of overland flow into streams and dry valleys generated higher flood waters well above the carrying capacities of the channels. The great volume and velocity of the overland flow, catalysed its erosive potential hence the excavation of gullies and unearthing of infrastructure (Figures 6 and 8). The rainfall characteristics in the pre-flood months but more especially the extreme rain events in the pre-flood occurrence days provide ample explanation of the unprecedented floods. However, the magnitude of the flood incidence necessitate recourse to be made to under indirect flood drivers. The rainfall characteristics in the pre-flood months but more especially the extreme rain events in the pre-flood occurrence days provide ample explanation of the unprecedented floods. However, the magnitude of the flood incidence necessitate recourse to be made to under indirect flood drivers.

Figure 15. Monthly Rainfall Intensities
Source: Drawn on the basis NASA Climatic Data

Mean Rainfall Intensities: The amount of rainfall occurring within unit time is crucial in rainfall-flood analysis since it determines the infiltration rate and capacity of an area hence the rainfall-run off coefficient. The daily rainfall variability and mean rainfall intensities of the areas on Figure 15, reveal upsurges in the flood months of September in Kumba and July in the Mutengene-Likomba zone.

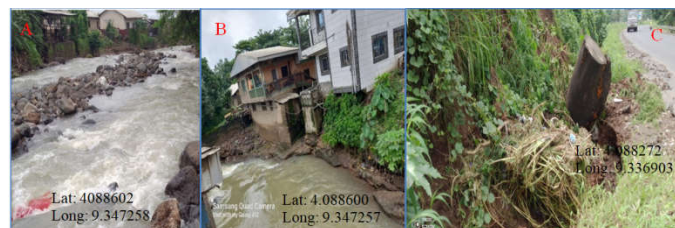
Landscape humanization: Though the rainfall flood nexus has been established, the unprecedented pattern of occurrence of the July 9 -September 4, 2022 flood warrants search for explanations beyond the nature-driven floods thesis. Consequently, an evaluation was made of the likely enabling connections of the floods and the vast landscape humanisation stemming from anthropic obstructions, constructions and destructions. Infrastructural designs and patterns have actually been done in respect to the topography of the area. Here, most of the housing facilities are made with planks “caraboots” while there are few in block and stone materials. Most of the houses clustered on the favourable locations for construction as the tablelands, hilltops, gentle slopes, plains and terraces. This clustering has installed a high housing density which is deepening and widening with time, with house spacing in most low-lying parts being 1 to 2m apart and also less than 2m away from the main road. This high nucleation of houses increases friction to overland flow thereby increasing surface detention and retention of water within the narrow tracks between the houses. This situation is exacerbated the preponderance of housing constructions directly on the natural, as well as the man-made drainage channels. These constructions constituted growing instances of drainage channels obstructions in area. Some of these unplanned construction of houses along the Likomba Riverbanks are shown Figures 16 A and B while artificial blockage of drainage channels is on Figure 16 C.

Figures 16. Scenes of anthropic constructions and obstructions on water course ways
Source: Fieldwork, 2022
